**OPERATIONS MANUAL**

## PHOTO EXPOSURE UNIT

DOCUMENT orm # / Org70 TECHNICAL MANUAL Number : MTCE004 Edition date: 18/11/2014 AFOSA with collimated light : General presentation Page: 1/9

Family of products : Kind of products :	EXPOSURE
Technology:	EXPOSURE UNIT
Application :	UV LIGHTS
Reference of the product	
ésignation :	
	Photo Exposure Unit AFOSA - COLLIMATED LIGHT
and the same of th	Photo exposure of PC Boards with dry film or photo resist on one or two sides

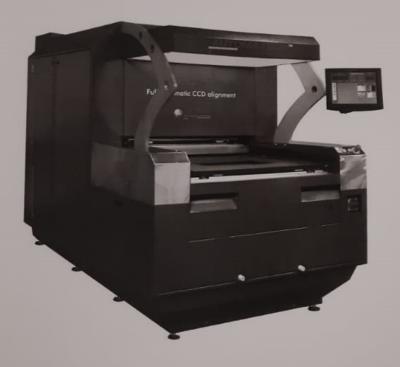
AFOSA — General presentation — Collimated light

Presentation of the item : AA044 ALTIX AUTOMA-TECH $^{\text{TM}}$  drawings : COM 1115-03
